**Subject: Navistar Safety Recall No. 99501
DOT No. 99V-033.001**

G-89501

**SUBJECT: VEHICLE RECALL (U.S., EXPORT)
Tie Rod Separation on 6000 & 8000 #
Capacity Dana Spicer Steer Axle**

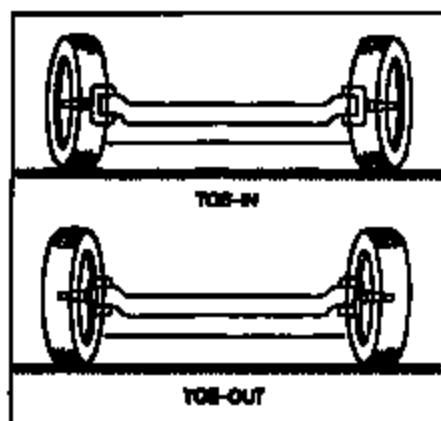
Figure 1

The following procedure may be used to set toe-in when electronic alignment equipment is not available. To obtain an accurate reading, two mechanics are required to insure that the pointers are always placed or adjusted to be exactly in front of the line scribed on both tires. Toe-in is the amount in fractions of an inch that the front wheels are closer together at the front than at the back (Figure 1).

1. Block rear wheel.
2. Jack up front axle.
3. Wipe off excess dirt and moisture from the center of both front tire treads complete 360°. Use a piece of caulk or white spray paint to mark the center area of both tires around the complete circumference.
4. Put a scribe or pointed instrument against the center of the whitened area of each tire and rotate the tires 360°. The scribe must be held in place so that a single thin straight line is marked all the way around the tires.

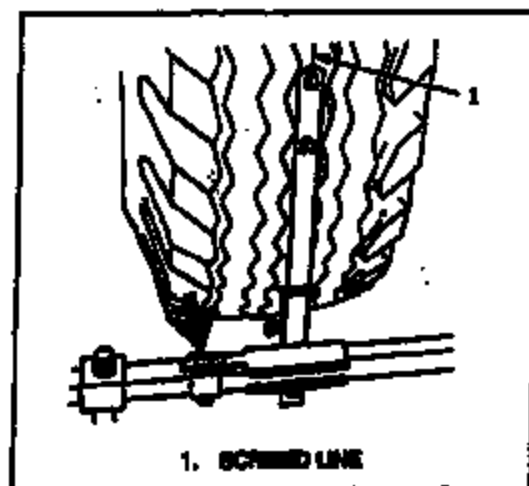
Figure 2

5. Put a floating radius gauge plate under each wheel. Lower the vehicle and remove the lock pins from the radius gauge plates to allow the front wheels to return to the normal operating position. If full floating radius gauges plates are not available, lower the vehicle to the floor and roll it forward 12 to 15 feet (3.65 to 4.57 m) to neutralize the front suspension. Neutralizing the front suspension is extremely important especially if the vehicle has been jacked up to scribe the tires; otherwise, the front wheels will not return to the normal operation position due to the tires gripping the floor surface when the vehicle is lowered.
6. Set the sliding scale end of the trammel bar to zero (0) (Figure 2) and lock the scale in place.

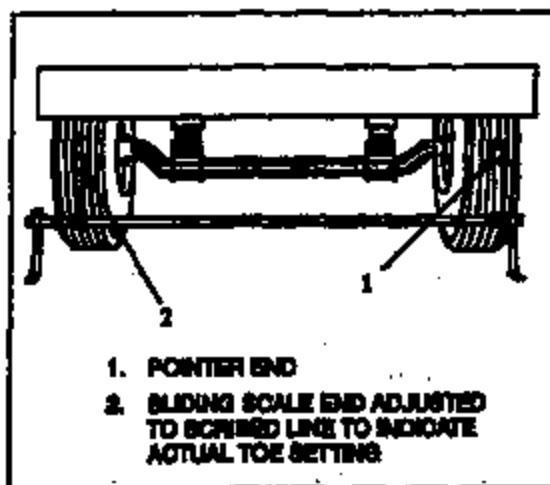
Figure 3

7. Put the trammel bar at the rear of the front tires so that the sliding scale that was set to zero in step 6 is centered against the scribed line on one of the tires (Figure 2).
8. Adjust the pointer on the end of the trammel bar opposite the sliding scale so it lines up with the scribed line on the rear of the opposite front tire. Lock the pointer in place on the trammel bar. Remove the trammel bar being careful not to contact either of the pointers.
9. Put the trammel bar against the front of the tires so the pointer end is aligned against the scribed line on the front tire. Loosen and remove the sliding scale pointer on the opposite end of the trammel bar so it is also aligned against the scribed line on the opposite tire. Lock the scale in place (Figure 3).

10. Read the toe-in or toe-out on the sliding scale. If toe-in is correct, it will read $1/16 \pm 1/16$ inch (0 – $1/8$ inch toe-in).

11. If toe-in is within the specification, position and tighten tie-rod clamps to 70-85 ft lbs.

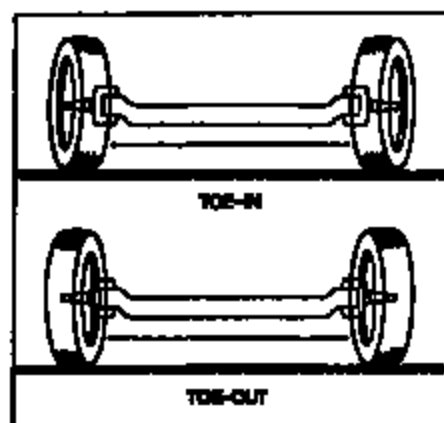
Figure 1

The following procedure may be used to set toe-in when electronic alignment equipment is not available. To obtain an accurate reading, two mechanics are required to insure that the pointers are always placed or adjusted to be exactly in front of the line scribed on both tires. Toe-in is the amount in fractions of an inch that the front wheels are closer together at the front than at the back (Figure 1).

1. Block rear wheel.
2. Jack up front axle.
3. Wipe off excess dirt and moisture from the center of both front tire treads complete 360°. Use a piece of caulk or white spray paint to mark the center area of both tires around the complete circumference.
4. Put a scribe or pointed instrument against the center of the whitened area of each tire and rotate the tires 360°. The scribe must be held in place so that a single thin straight line is marked all the way around the tires.

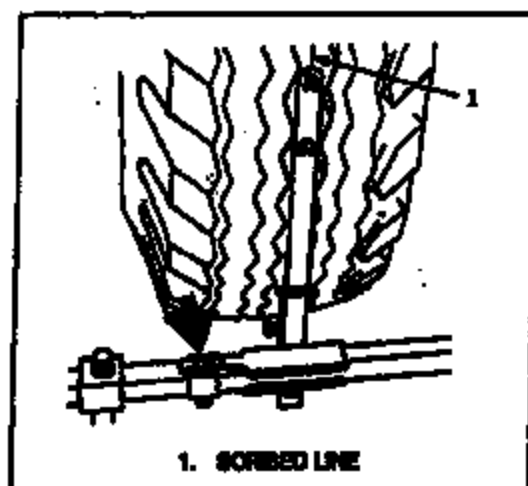
Figure 2

5. Put a floating radius gauge plate under each wheel. Lower the vehicle and remove the lock pins from the radius gauge plates to allow the front wheels to return to the normal operating position. If full floating radius gauges plates are not available, lower the vehicle to the floor and roll it forward 12 to 15 feet (3.65 to 4.57 m) to neutralize the front suspension. Neutralizing the front suspension is extremely important especially if the vehicle has been jacked up to scribe the tires; otherwise, the front wheels will not return to the normal operation position due to the tires gripping the floor surface when the vehicle is lowered.
6. Set the sliding scale end of the trammel bar to zero (0) (Figure 2) and lock the scale in place.

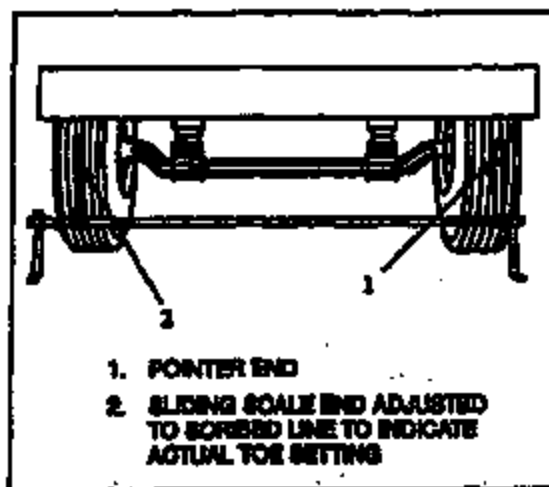
Figure 3

7. Put the trammel bar at the rear of the front tires so that the sliding scale that was set to zero in step 6 is centered against the scribed line on one of the tires (Figure 2).
8. Adjust the pointer on the end of the trammel bar opposite the sliding scale so it lines up with the scribed line on the rear of the opposite front tire. Lock the pointer in place on the trammel bar. Remove the trammel bar being careful not to contact either of the pointers.
9. Put the trammel bar against the front of the tires so the pointer end is aligned against the scribed line on the front tire. Loosen and remove the sliding scale pointer on the opposite end of the trammel bar so it is also aligned against the scribed line on the opposite tire. Lock the scale in place (Figure 3).

10. Read the toe-in or toe-out on the sliding scale. If toe-in is correct, it will read $1/16 \pm 1/16$ inch (0 – $1/8$ inch toe-in).
11. If toe-in is within the specification, position and tighten tie-rod clamps to 70-85 ft lbs.

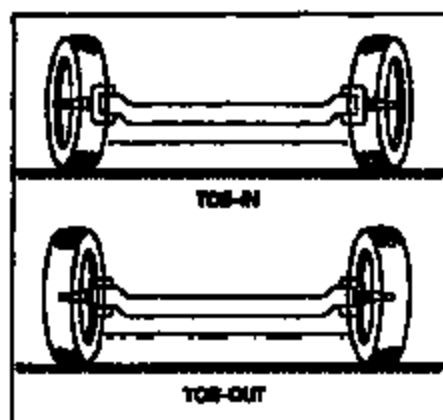
Figure 1

The following procedure may be used to set toe-in when electronic alignment equipment is not available. To obtain an accurate reading, two mechanics are required to insure that the pointers are always placed or adjusted to be exactly in front of the line scribed on both tires. Toe-in is the amount in fractions of an inch that the front wheels are closer together at the front than at the back (Figure 1).

1. Block rear wheel.
2. Jack up front axle.
3. Wipe off excess dirt and moisture from the center of both front tire treads complete 360°. Use a piece of caulk or white spray paint to mark the center area of both tires around the complete circumference.
4. Put a scribe or pointed instrument against the center of the whitened area of each tire and rotate the tires 360°. The scribe must be held in place so that a single thin straight line is marked all the way around the tires.

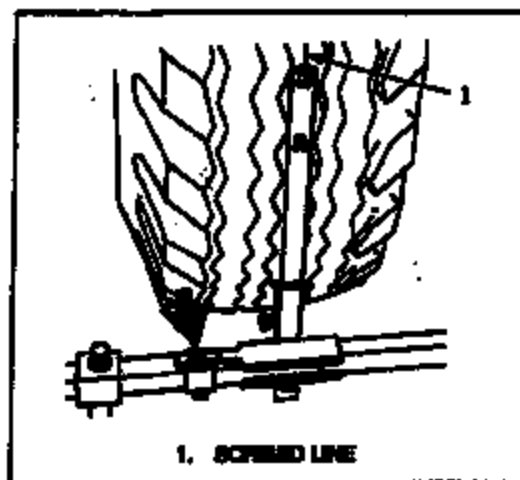
Figure 2

5. Put a floating radius gauge plate under each wheel. Lower the vehicle and remove the lock pins from the radius gauge plates to allow the front wheels to return to the normal operating position. If full floating radius gauges plates are not available, lower the vehicle to the floor and roll it forward 12 to 15 feet (3.65 to 4.57 m) to neutralize the front suspension. Neutralizing the front suspension is extremely important especially if the vehicle has been jacked up to scribe the tires; otherwise, the front wheels will not return to the normal operation position due to the tires gripping the floor surface when the vehicle is lowered.
6. Set the sliding scale end of the trammel bar to zero (0) (Figure 2) and lock the scale in place.

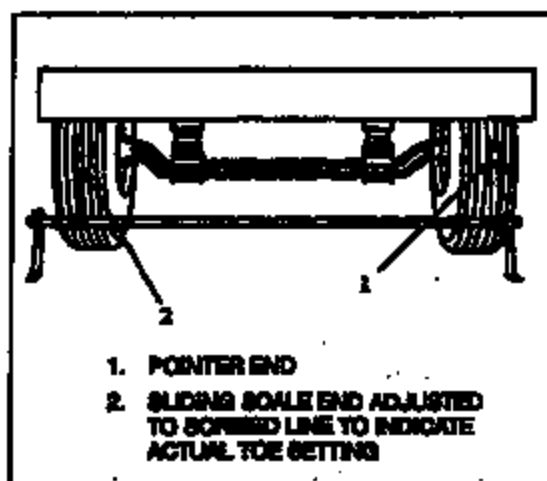
Figure 3

7. Put the trammel bar at the rear of the front tires so that the sliding scale that was set to zero in step 6 is centered against the scribed line on one of the tires (Figure 2).
8. Adjust the pointer on the end of the trammel bar opposite the sliding scale so it lines up with the scribed line on the rear of the opposite front tire. Lock the pointer in place on the trammel bar. Remove the trammel bar being careful not to contact either of the pointers.
9. Put the trammel bar against the front of the tires so the pointer end is aligned against the scribed line on the front tire. Loosen and remove the sliding scale pointer on the opposite end of the trammel bar so it is also aligned against the scribed line on the opposite tire. Lock the scale in place (Figure 3).

10. Read the toe-in or toe-out on the sliding scale. If toe-in is correct, it will read $1/16 \pm 1/16$ inch (0 – $1/8$ inch toe-in).
11. If toe-in is within the specification, position and tighten tie-rod clamps to 70-85 ft lbs.
